**Flood Control Project Maintenance
Levee Inspections**
LMA District Cover Sheet
Spring 2017 Levee Inspection Results

Reclamation District No. 0150 Merrit Island

Spring 2017 Levee Inspection Results

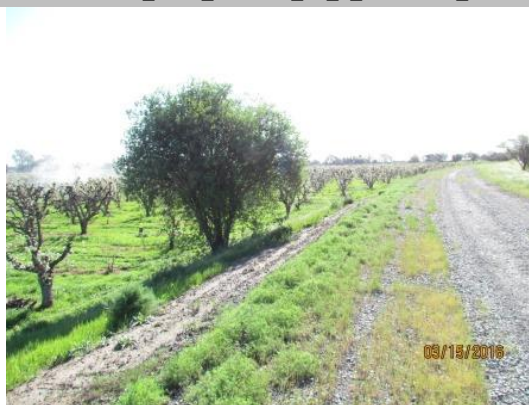
Photo 1 of 1 : SP_2017_RD0150_15_3_20170327_00003.jpg

View of the elderberry on the landside toe of the levee. The elderberry doesn't block visibility and it is trimmed up 5 feet above the slope.

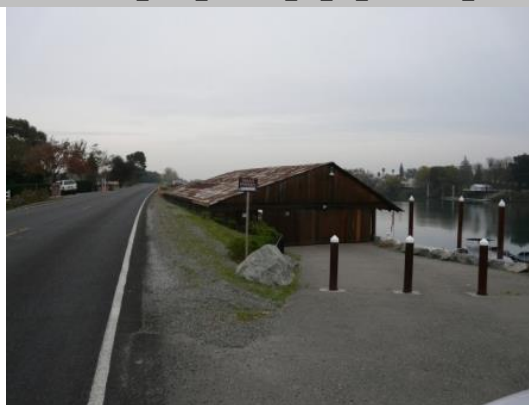
Photo 1 of 1 : SP_2017_RD0150_16_49_20170327_00024.jpg

Building located on waterside of levee.

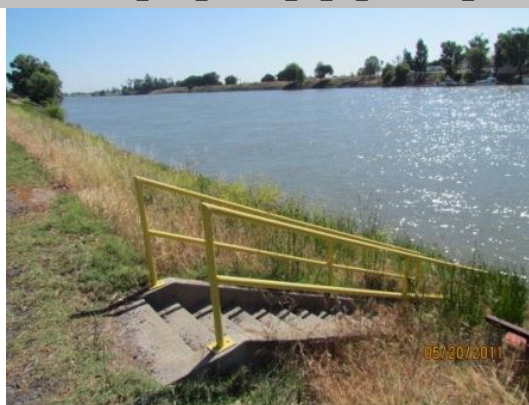
Photo 1 of 1 : SP_2017_RD0150_16_13_20170327_00009.jpg

A stairway was found on the waterside of the levee. The picture was taken from the crown looking upstream.

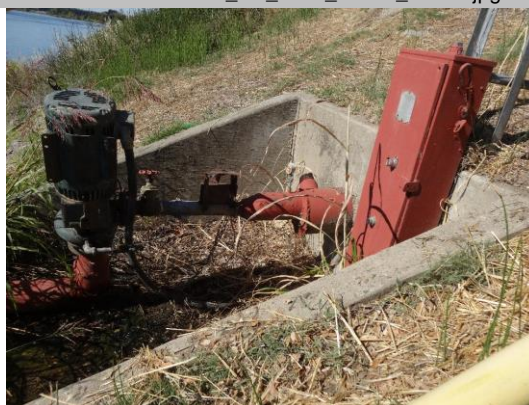
Photo 2 of 3 : UCIP_SP_2017_20268_34243.jpg

WS view: pump, electric control box, electric conduit on concrete pad.
Water leaks from pressure breaker.

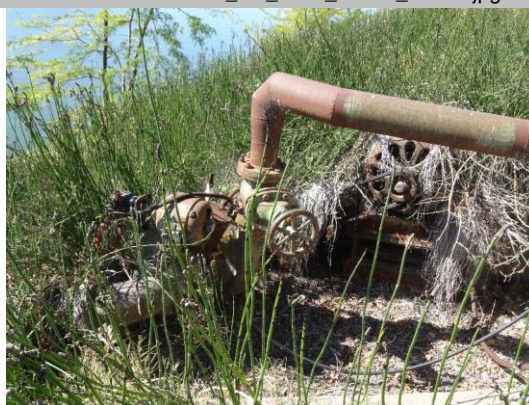
Photo 3 of 3 : UCIP_SP_2017_20267_34237.jpg

WS view: steel pipe, gate valve, and pump on levee slope. Seems abandoned.

FS_ID:20284
DS_ID:22419
EP_NO: N/A
Repair Type: Non-Urgent
Crossing Status: Found
UCIP Comments: Needs proper abandonment.
FIELD_STRUCT_DESC: 8-inch steel pipe through the levee, 5.7 feet below the crown. Power line on landside.(Mrs. J. Olson) O&M Manual SAC 112, March 1957.
FS Date: 8/27/2013

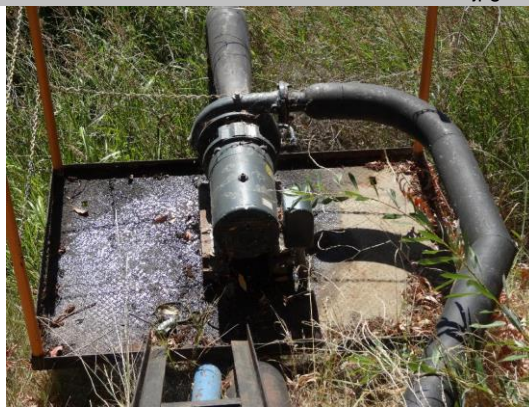
Photo 2 of 3 : UCIP_SP_2017_20303_34286.jpg

WS view: steel pipes and leaky slant pump on steel deck.

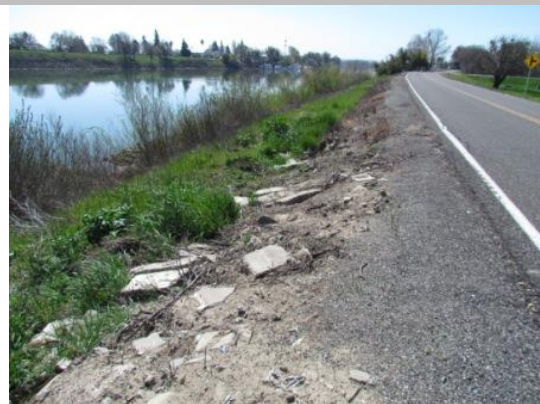
Photo 1 of 1 : SP_2017_RD0150_16_10_20170327_00007.jpg

LM Start	0.71	Rating **	M	Issue No.	10
LM End	0.71	Issue Type +	Ma	Location *	WS
Category	Earthen Levee			GPS Latitude/Longitude	
				Start	End
Item	Encroachments			38.336228 °	38.336228 °
				-121.568332 °	-121.568332 °
DWR ID	DWR_RD0150_02_s_2013_10				
Comment Code					
DE : Debris					
Inspector Comment

Debris was found on the waterside slope of the levee looking downstream during Spring 2013 inspection.

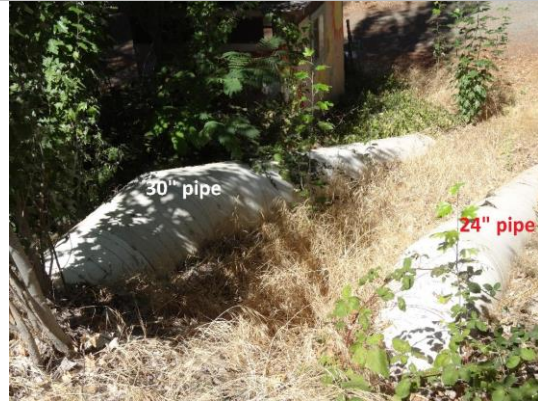
Photo 3 of 3 : UCIP_SP_2017_20346_34348.jpg

LS view: exposed 30" pipe (left) and 24" pipe (right) on levee slope.

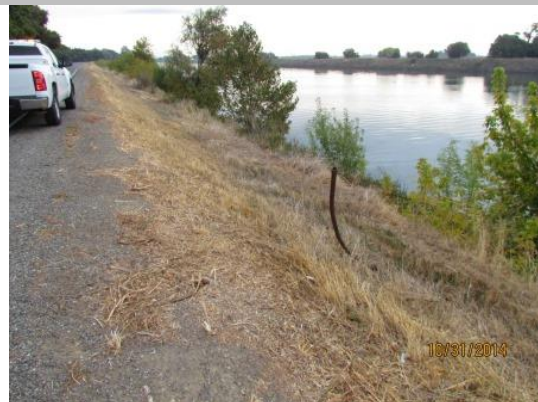
Photo 1 of 1 : SP_2017_RD0150_16_48_20170327_00023.jpg

A pole/pipe was found on the waterside slope of the levee looking upstream.

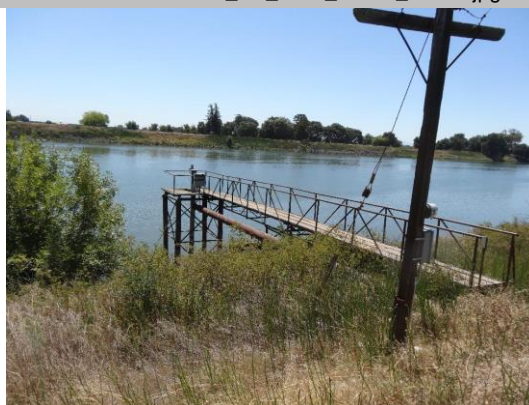
Photo 1 of 3 : UCIP_SP_2017_20348_34371.jpg

WS view: service pole, pipe & pump on piling structure in the stream.

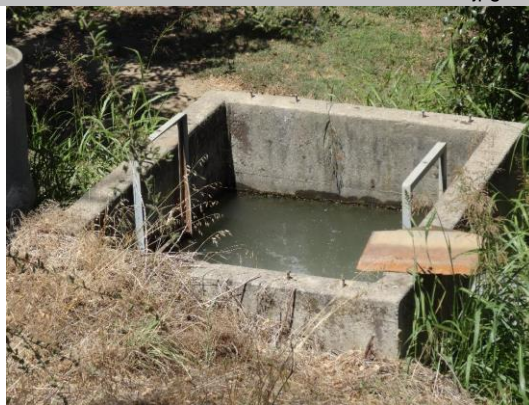
Photo 3 of 3 : UCIP_SP_2017_20348_34369.jpg

LS view: concrete distribution box on levee toe.

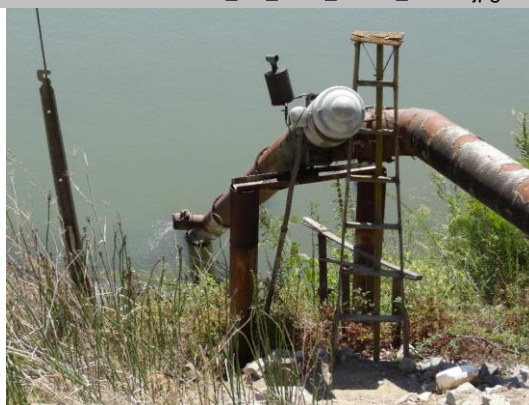
Photo 1 of 3 : UCIP_SP_2017_20731_34902.jpg

WS view: slant pump on steel frame support and exposed pipe on levee slope.

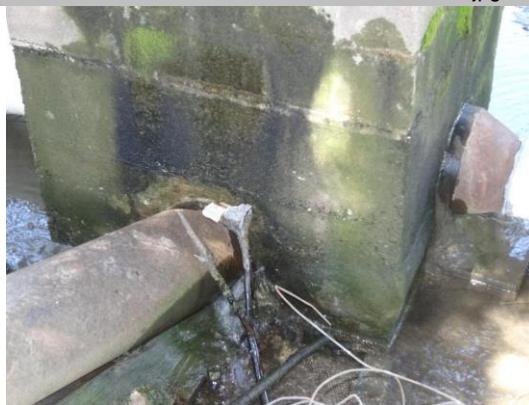
Photo 3 of 3 : UCIP_SP_2017_20731_34903.jpg

LS view: leaky concrete distribution box on levee toe.

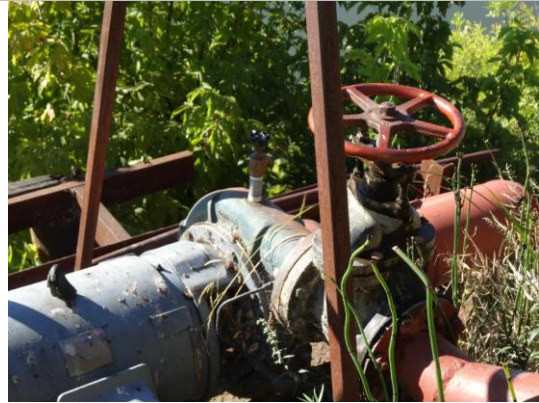
Photo 3 of 3 : UCIP_SP_2017_20736_34915.jpg

WS view: pipe and pump on levee slope. Gate valve and air vent on the pipe.

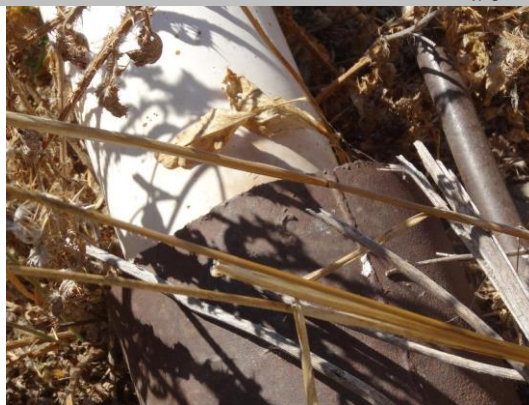
Photo 2 of 3 : UCIP_SP_2017_19846_33726.jpg

WS view: steel conduit (right); 8" pvc pipe sleeved into 12" steel pipe.

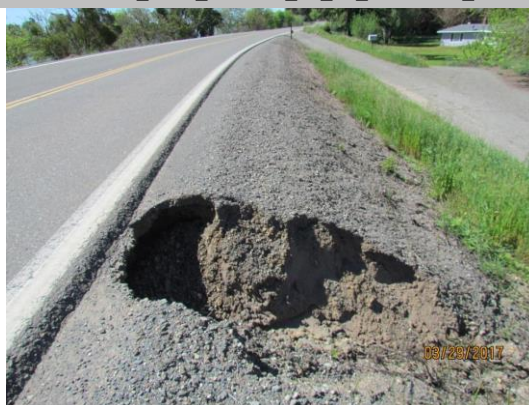
Photo 1 of 1 : SP_2017_RD0150_16_67_20170405_00119.jpg

View of a slope instability on the landside of the levee looking downstream.

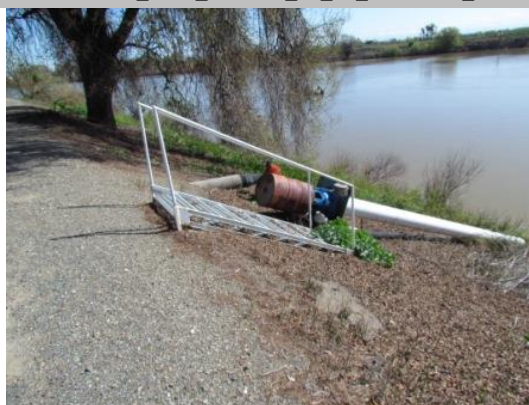
Photo 1 of 1 : SP_2017_RD0150_16_33_20170327_00019.jpg

A stairway was found on the waterside slope of the levee.

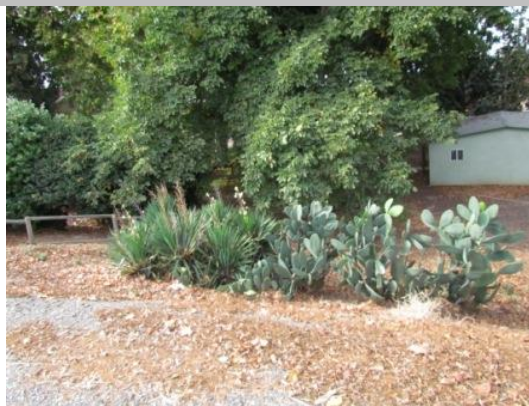
Photo 1 of 1 : SP_2017_RD0150_16_953_20170327_00050.jpg

View of cacti on the landside of the levee looking from the crown.

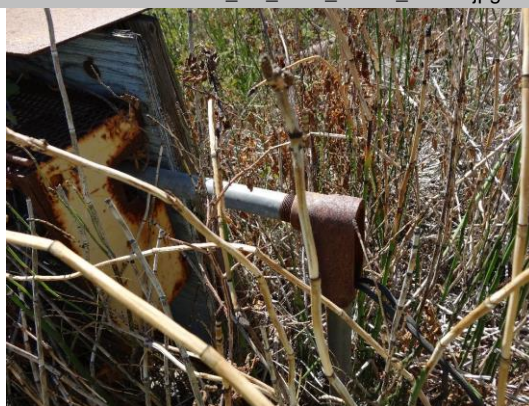
Photo 3 of 3 : UCIP_SP_2017_42702_33780.jpg

WS view: electric control box and electric conduit on levee slope.

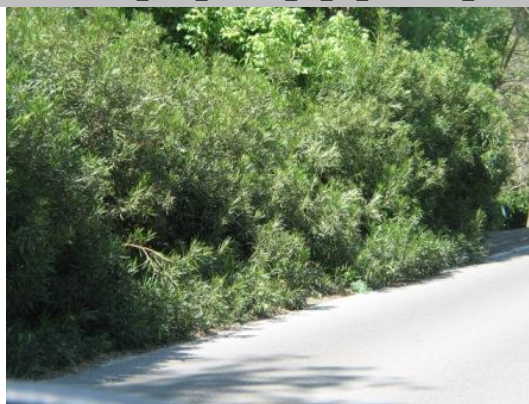
Photo 1 of 1 : SP_2017_RD0150_16_24_20170327_00014.jpg

Landscaping (Oleander) on landward slope from 4.33 to 4.35

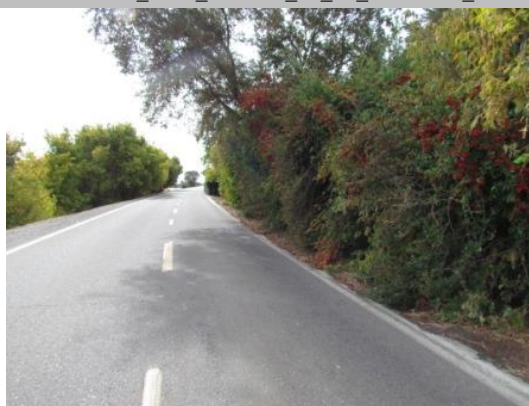
Photo 1 of 1 : SP_2017_RD0150_16_79_20170327_00043.jpg

Trees were obstructing the views on the landside slope of the levee looking downstream.

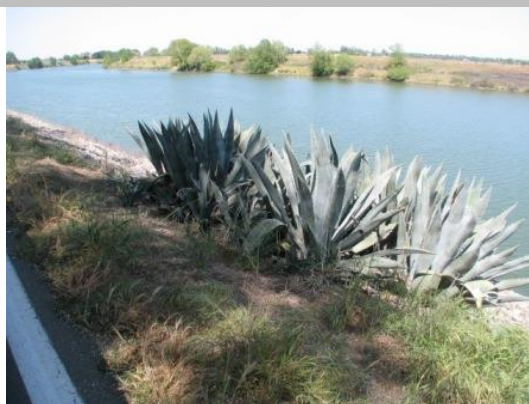
Photo 1 of 1 : SP_2017_RD0150_16_28_20170327_00016.jpg

Century plant on waterward slope at LM 4.76

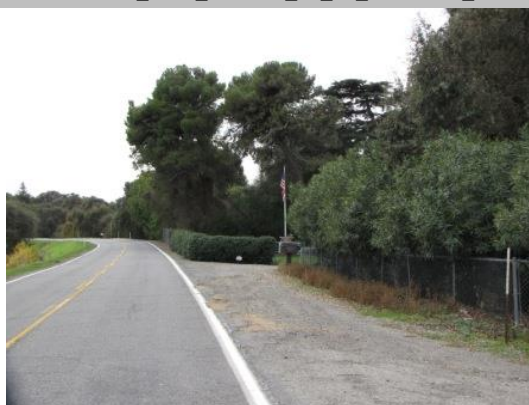
Photo 1 of 1 : SP_2017_RD0150_16_75_20170327_00041.jpg

View of landscaping along the landward shoulder and slope looking downstream.

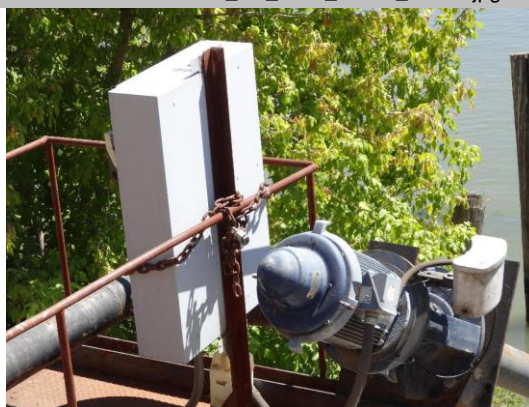
Photo 2 of 3 : UCIP_SP_2017_20740_34940.jpg

WS view: pipe, slant pump & pump platform on stream bank.

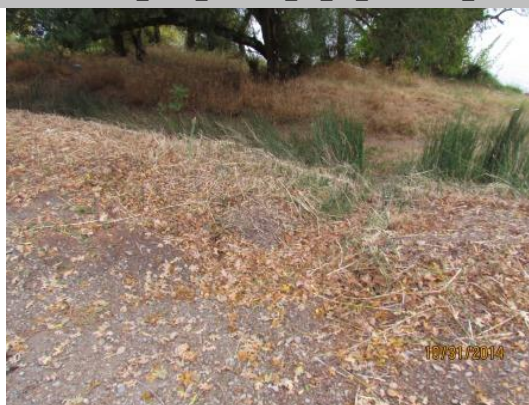
Photo 1 of 1 : SP_2017_RD0150_16_54_20170327_00027.jpg

View of a slope instability on the waterside of the levee looking towards the toe.

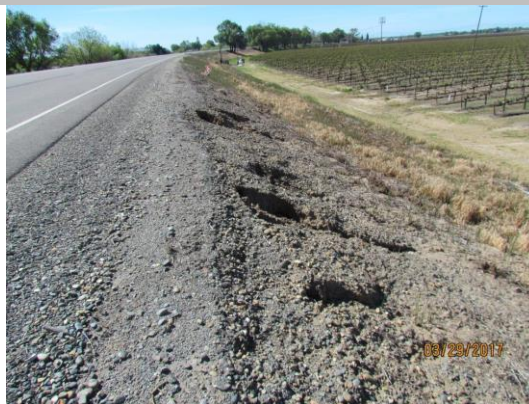
Photo 1 of 2 : SP_2017_RD0150_16_52_20170405_00118.jpg

Updated picture of the erosion on the landside of the levee during spring 2017 inspection.

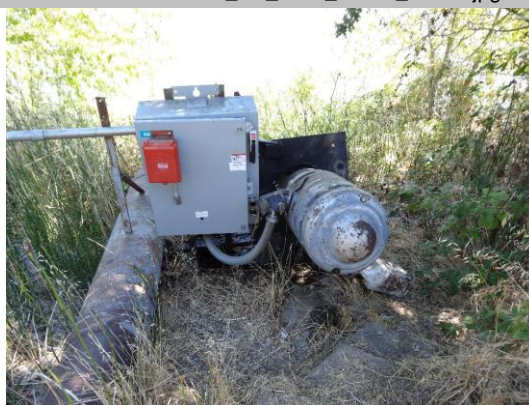
Photo 1 of 3 : UCIP_SP_2017_20748_34967.jpg

WS view: steel pipe and slant pump on levee slope.

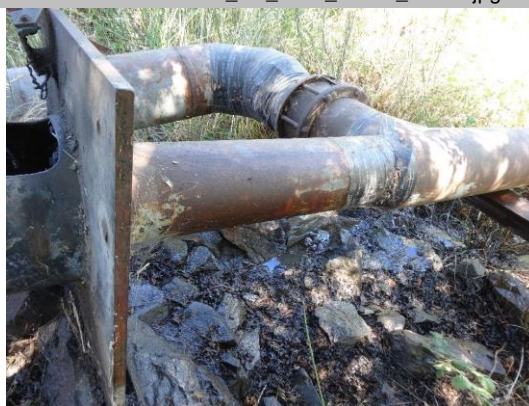
Photo 2 of 3 : UCIP_SP_2017_20748_34966.jpg

WS view: leaky steel pipe and slant pump on levee slope.

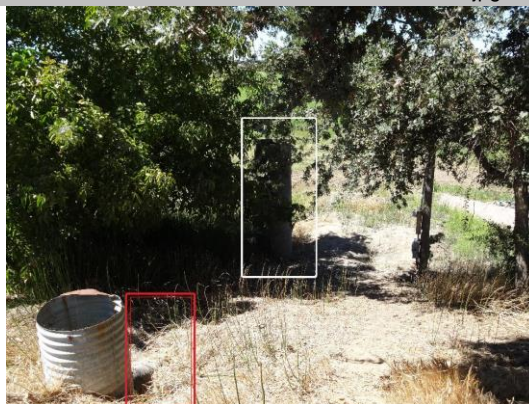
Photo 3 of 3 : UCIP_SP_2017_20748_34965.jpg

LS view: siphon breaker in CMP riser (left) on levee slope and concrete standpipe at levee toe (right).

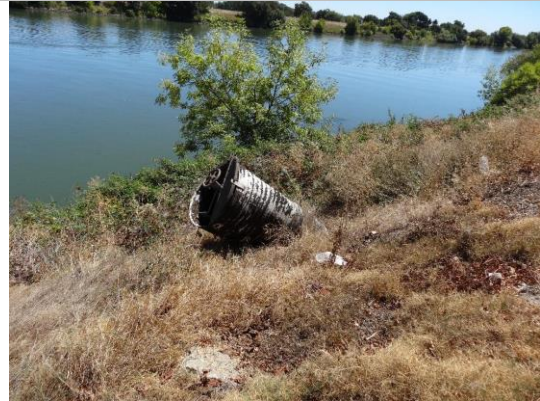
Photo 3 of 3 : UCIP_SP_2017_50669_34983.jpg

WS view: an abandoned and dismantled CMP riser with gate valve handle on WS levee slope.

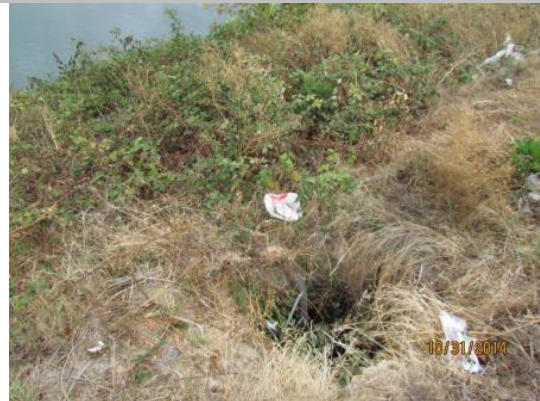
Photo 1 of 1 : SP_2017_RD0150_16_55_20170327_00028.jpg

An open pipe valve was found without a cover on the waterside toe of the levee.

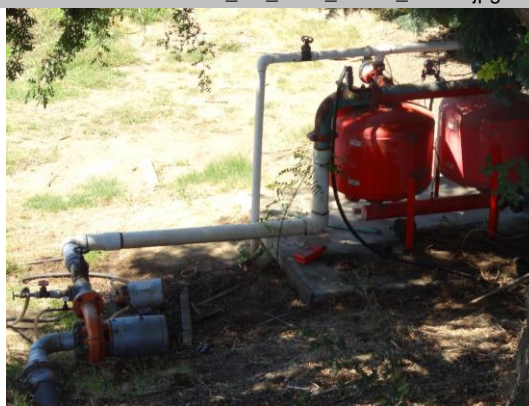
Photo 2 of 2 : UCIP_SP_2017_41720_34080.jpg

LS view: concrete vault, pipe, and pump in water filtration plant.

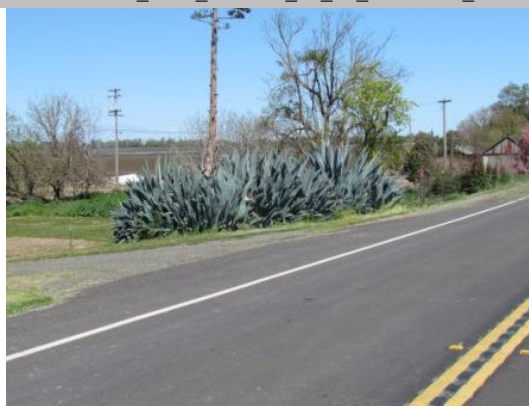
Photo 1 of 1 : SP_2017_RD0150_16_43_20170327_00022.jpg

Century plants were found on the landside of the levee looking upstream.

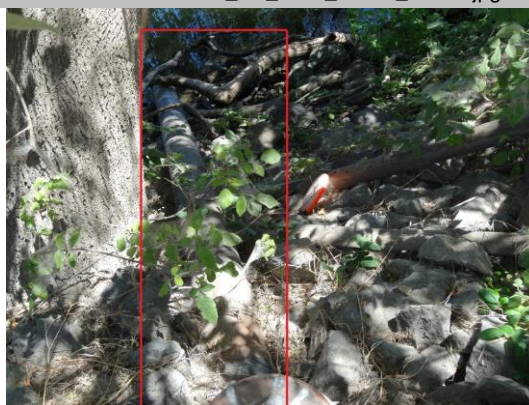
Photo 1 of 3 : UCIP_SP_2017_41646_34102.jpg

WS view: inlet steel pipe on stream bank.

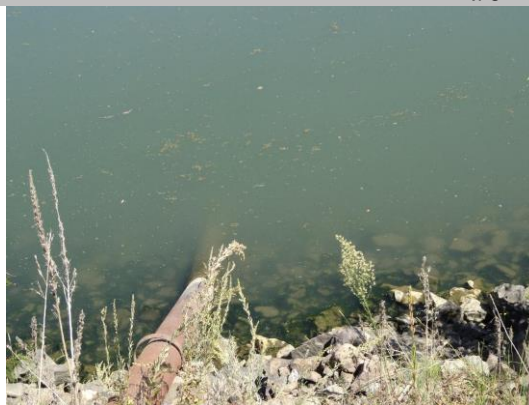
Photo 2 of 3 : UCIP_SP_2017_50387_35001.jpg

WS view: steel inlet pipe in the stream and bank.

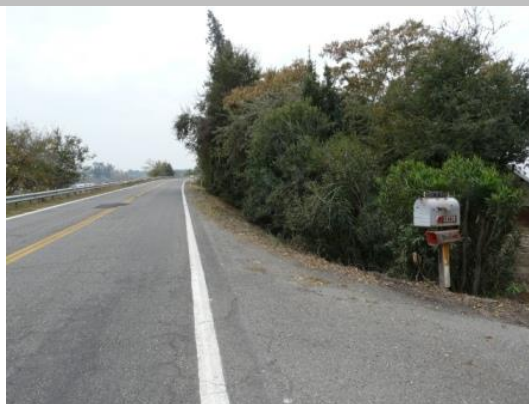
Photo 1 of 1 : SP_2017_RD0150_16_60_20170327_00034.jpg

Landscaping providing a screen for a residence on the landside of levee from LM 6.93 to LM 7.05

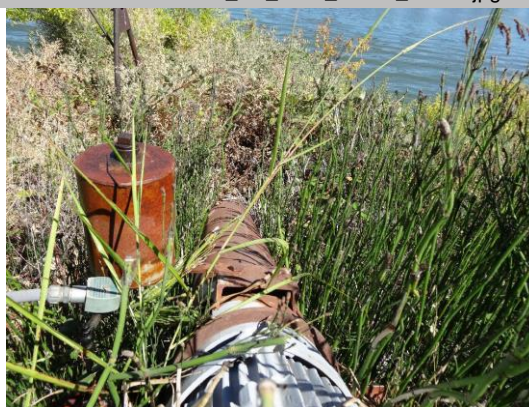
Photo 2 of 3 : UCIP_SP_2017_50386_34161.jpg

WS view: steel intake pipe and pump on levee slope. Dense vegetation on levee slope.

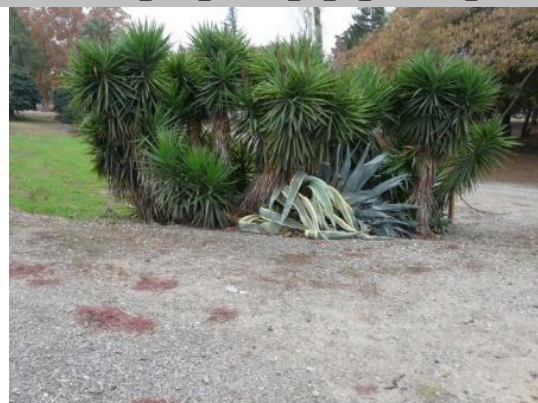
Photo 1 of 1 : SP_2017_RD0150_16_56_20170327_00029.jpg

Landscaping on landside of levee at LM 7.92

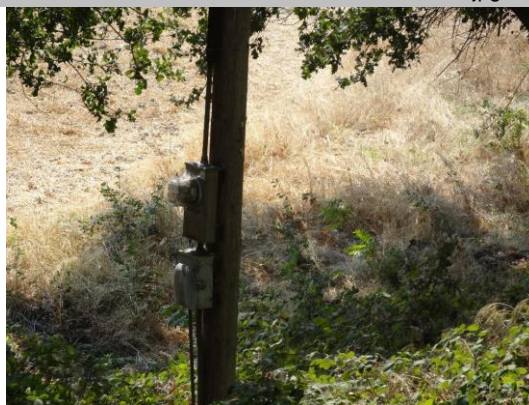
Photo 1 of 3 : UCIP_SP_2017_42693_31979.jpg

LS view: service pole on levee slope.

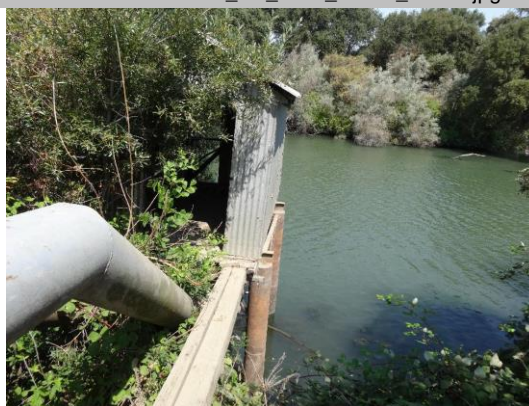
Photo 3 of 3 : UCIP_SP_2017_19112_32042.jpg

WS view: pipe, wooden walkway and pump house in channel.

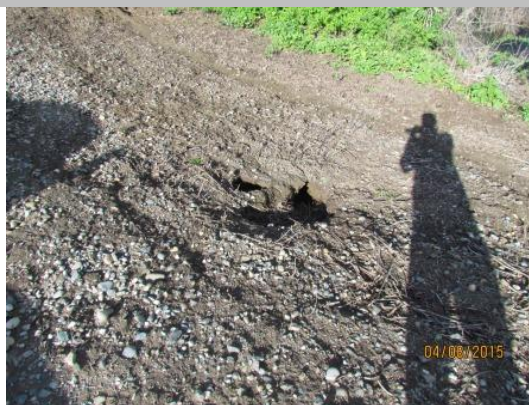
Photo 1 of 1 : SP_2017_RD0150_17_393_20170327_00083.jpg

Rodent holes were found on the waterside of the levee looking downstream.

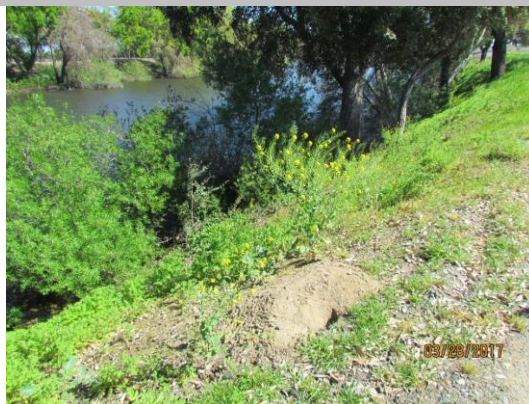
Photo 1 of 1 : SP_2017_RD0150_17_46_20170330_00137.jpg

View of a rodent hole on the waterside slope of the levee.

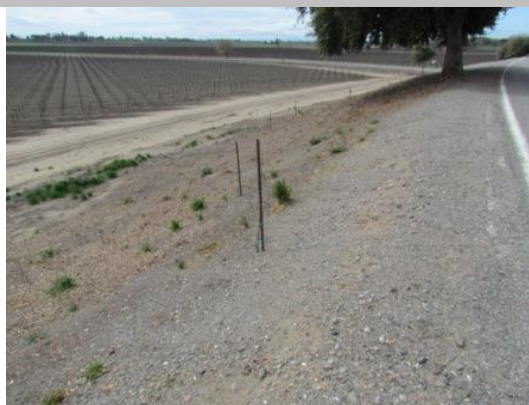
Photo 4 of 4 : SP_2017_RD0150_17_78_20170327_00059.jpg

New tree was planted on the landside of the levee looking downstream.

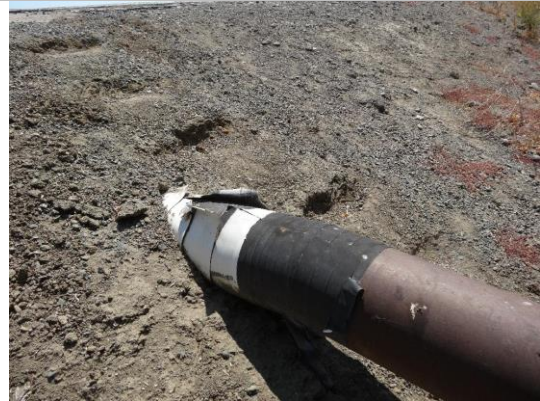
Photo 3 of 3 : UCIP_SP_2017_51467_35011.jpg

LS view: exposed pipe on levee slope.

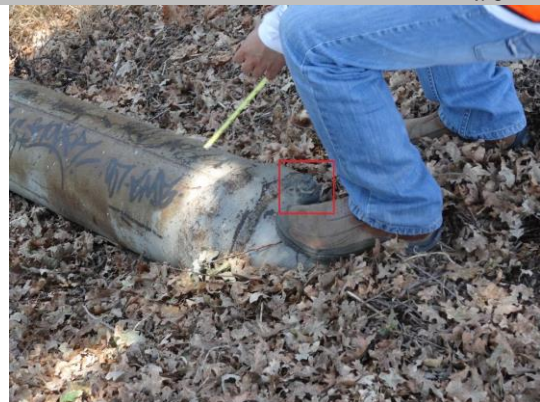
Photo 2 of 3 : UCIP_SP_2017_50202_35021.jpg

WS view: steel pipe with safety valve (marked) on levee slope.

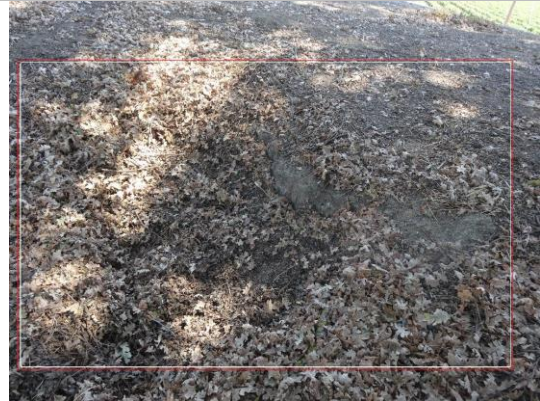
Photo 3 of 3 : UCIP_SP_2017_50202_35017.jpg

WS view: soil erosion (depression) on levee slope.

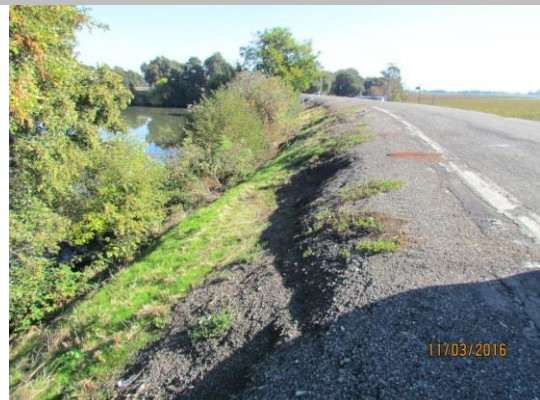
Photo 1 of 1 : SP_2017_RD0150_17_116_20170327_00082.jpg

View of slope instability on the waterside of the levee. Fall 2016

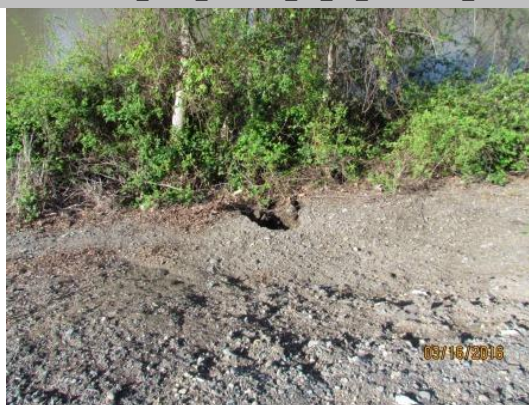
Photo 1 of 1 : SP_2017_RD0150_17_93_20170327_00072.jpg

An erosion was found on the waterside toe of the levee.

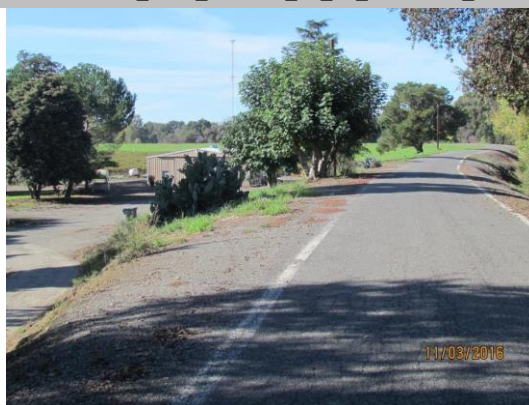
Photo 1 of 1 : SP_2017_RD0150_17_94_20170327_00073.jpg

View of landscape on the landside shoulder of the levee.

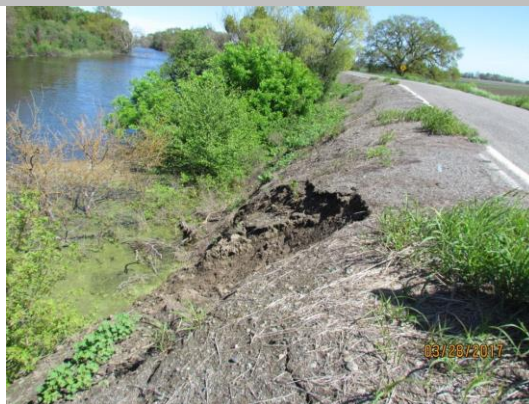
Photo 1 of 1 : SP_2017_RD0150_17_97_20170330_00145.jpg

View of an erosion on the waterside of the levee looking upstream.

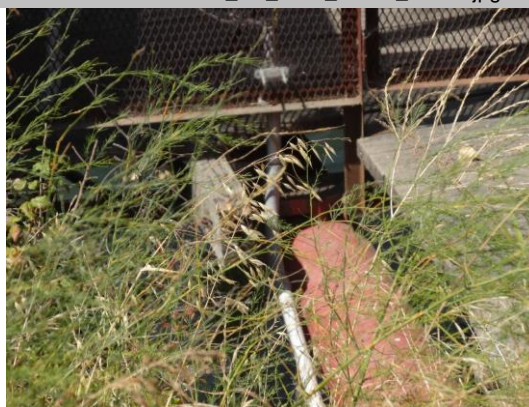
Photo 2 of 3 : UCIP_SP_2017_19281_32540.jpg

WS view: 1-inch GI conduit (left) and steel pipe (right)

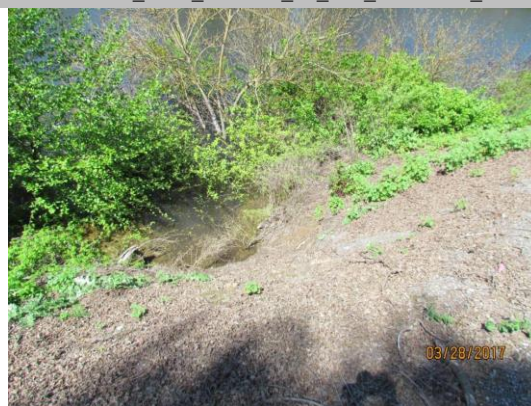
Photo 1 of 1 : SP_2017_RD0150_17_101_20170330_00146.jpg

View of an erosion on the waterside toe of the levee.

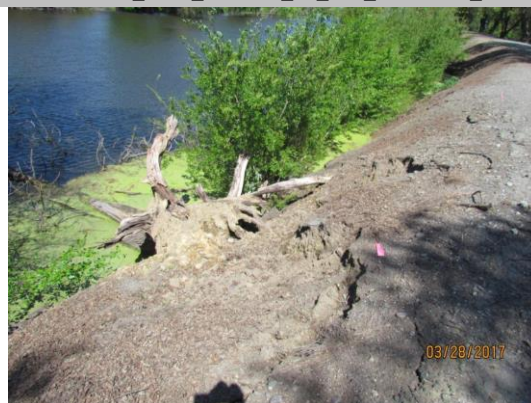
Photo 1 of 1 : SP_2017_RD0150_17_103_20170330_00147.jpg

View of an erosion due to damaged tree root on the waterside toe of the levee.

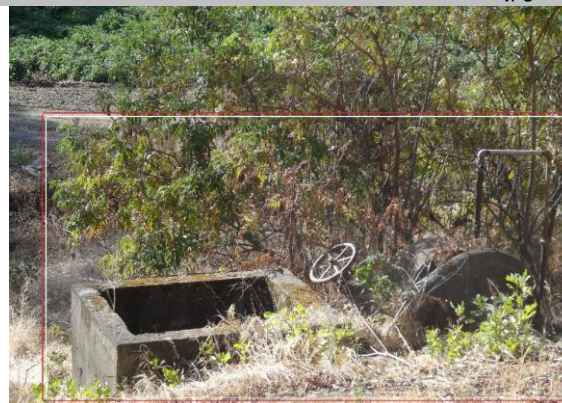
Photo 2 of 3 : UCIP_SP_2017_19283_32564.jpg

LS view: abandoned pump set and concrete box on levee slope.

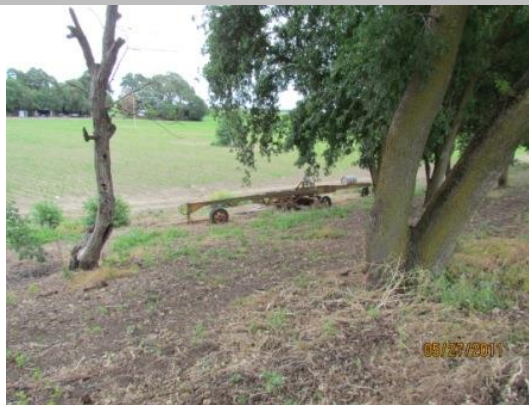
Photo 1 of 1 : SP_2017_RD0150_17_9_20170327_00003.jpg

Equipment on the landside toe of the levee. The picture was taken from crown looking downstream.

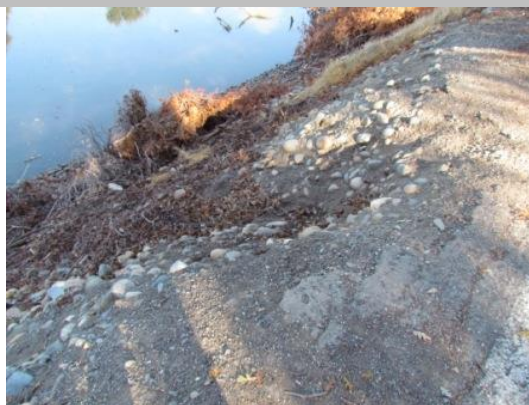
Photo 2 of 2 : SP_2017_RD0150_17_36_20170327_00024.jpg

Slope instability was found on the waterside of the levee looking upstream.

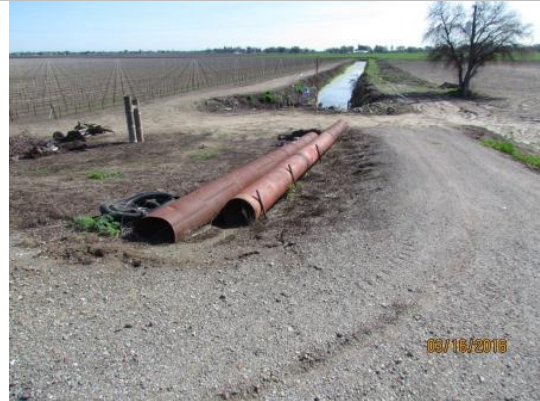
Photo 1 of 1 : SP_2017_RD0150_17_95_20170327_00074.jpg

View of an abandoned pipe on the landside slope of the levee.

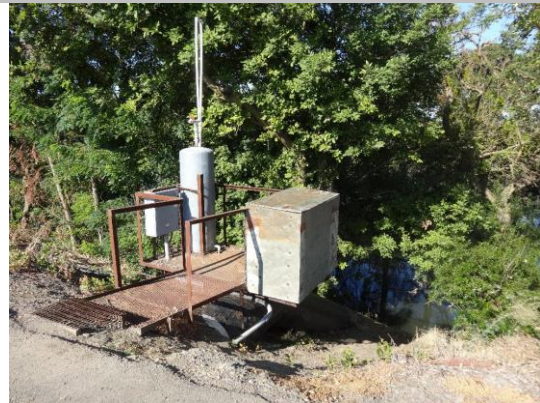
Photo 1 of 3 : UCIP_SP_2017_49386_63902.jpg

WS view: pipe, steel deck, pressure tank, electric control box on stream bank.

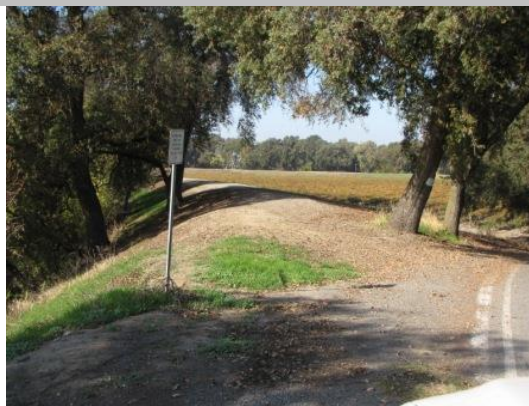
Photo 1 of 1 : SP_2017_RD0150_17_941_20170327_00090.jpg

View of varying elevations in the crown of the levee at the transition from county road to access road.

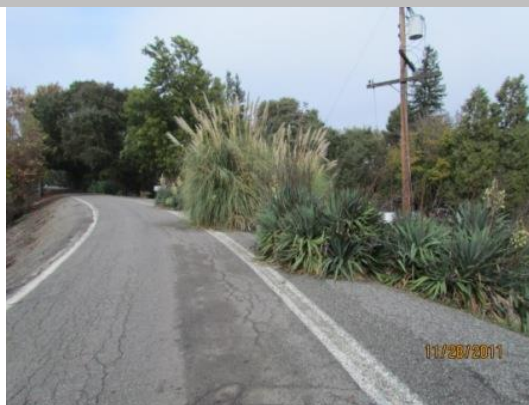
Photo 1 of 1 : SP_2017_RD0150_17_21_20170327_00011.jpg

Landscaping was found on the landside of the levee looking upstream.

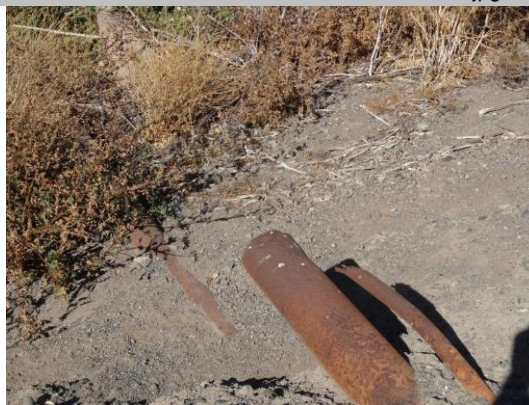
Photo 2 of 3 : UCIP_SP_2017_19403_32941.jpg

WS view: Abandoned concrete box (top). Open ended 6" steel pipe, 1" steel pipe, and another 6" steel pipe on levee slope.

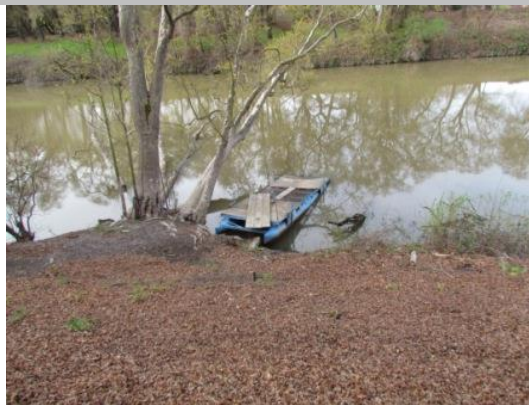
Photo 1 of 1 : SP_2017_RD0150_17_44_20170327_00028.jpg

An abandoned dock was found on the waterside of the levee looking upstream.

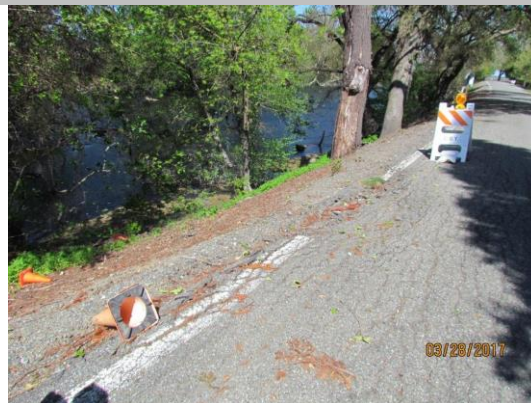
Photo 1 of 1 : SP_2017_RD0150_17_105_20170330_00149.jpg

View of depression and cracks on the waterside shoulder of the levee.

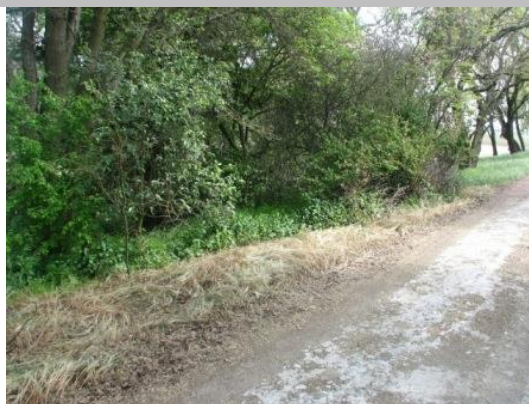
Photo 2 of 2 : SP_2017_RD0150_17_32_20170327_00019.jpg

Landscaping on landward slope blocking view from LM 7.42 to 7.47

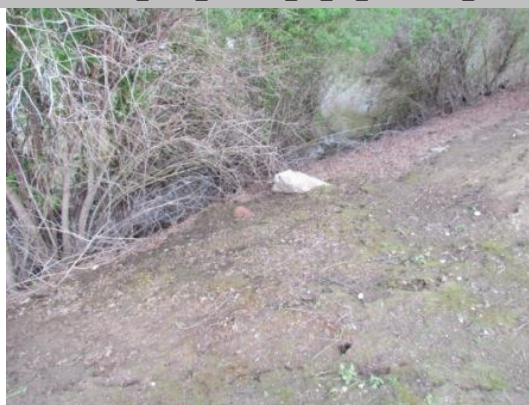
Photo 1 of 1 : SP_2017_RD0150_17_87_20170327_00066.jpg

A concrete block was found on the waterside of the levee looking upstream.
